Client	Project	Title
El Paso County Water Authority	El Paso County Water Report	Water Level Change Graph Greenland Ranch Satellite Wellfield Denver Aquifer Monitoring Points 1, 3 and 5
<i>JCHA/Knight Piesold and Co.</i>		
Project No: 5633:4F		Date: 06/25/02
		Fig. No: 11-10

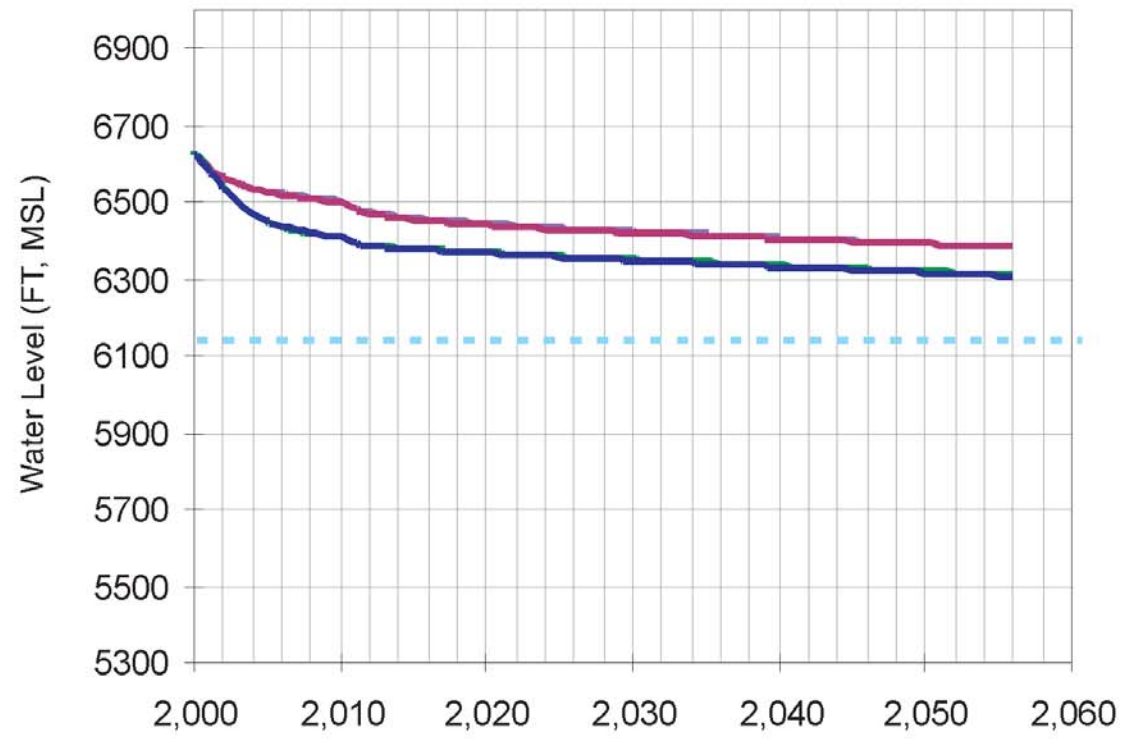
**Denver 1**

- 100 and 300 year rule (existing conditions)
- All on 100 year rule
- All on 100 year rule with Greenland Ranch satellite wellfield
- 100 and 300 year rule with Greenland Ranch satellite wellfield
- - - Top of Aquifer (FT,MSL)

- NOTES: 1. See Figure 11-1 for monitoring point locations and centroid of Greenland Ranch satellite wellfield.  
 2. Blue line is coincident with green line on these graphs, i.e. no water level difference in the two cases.  
 3. Purple line is coincident with red line on the Falcon graph, i.e. no water level difference in the two cases.
